MAINTENANCE AND CONDITION ASSESMENT

SITE ADDRESS:  
CELL SITE ID: 10126045  
FAA SITE NUMBER; NA  
ASSESMENT OF WATER TANK STRUCTURE FOR INFINIGY

ON DECEMBER 12TH 2019 FIREFLY TECHNICAL SERVICES LLC PERFORMED A VISUAL INSPECTION AND MAPPING OF SUBJECT SITE FOR TIA STANDARDS AND GENERAL CONDITIONS ASSESMENT.

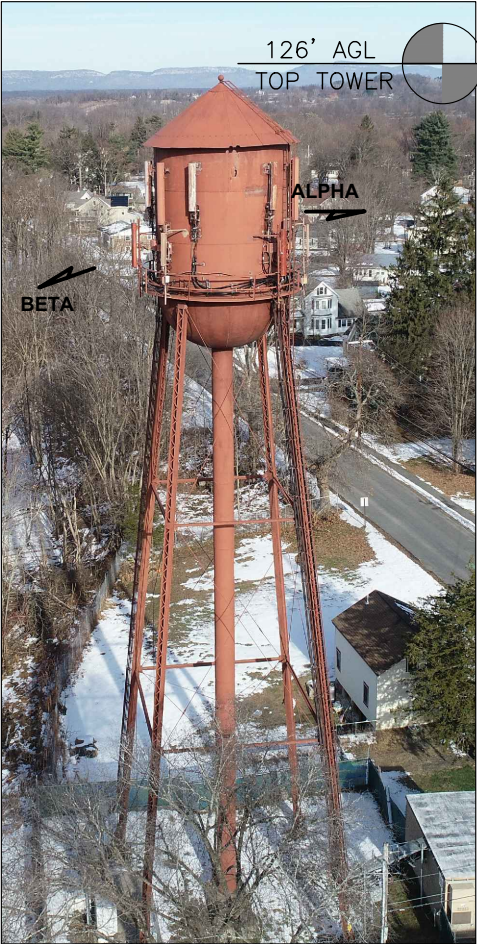
OVERALL WATER TANK

LATERAL SUPPORT LEGS OF WATER TANK HAVE BEEN RETROFITTED WITH STIFFENERS.

LIGHTNING PROTECTION IS NOT THE HIGHEST APPURTENANCE.

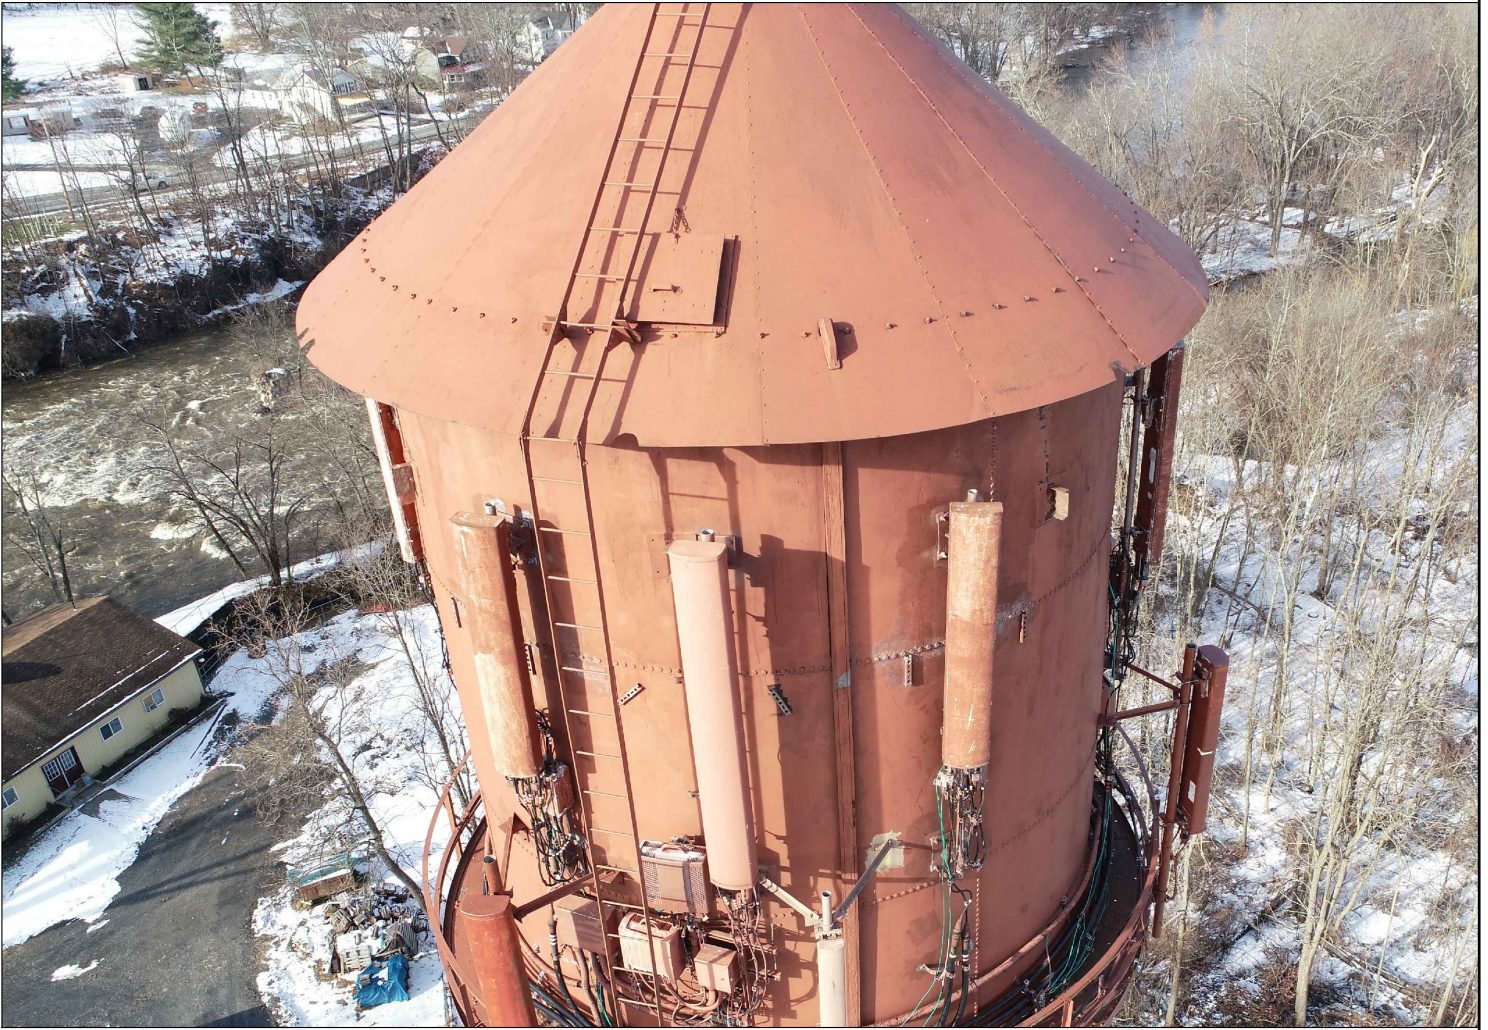
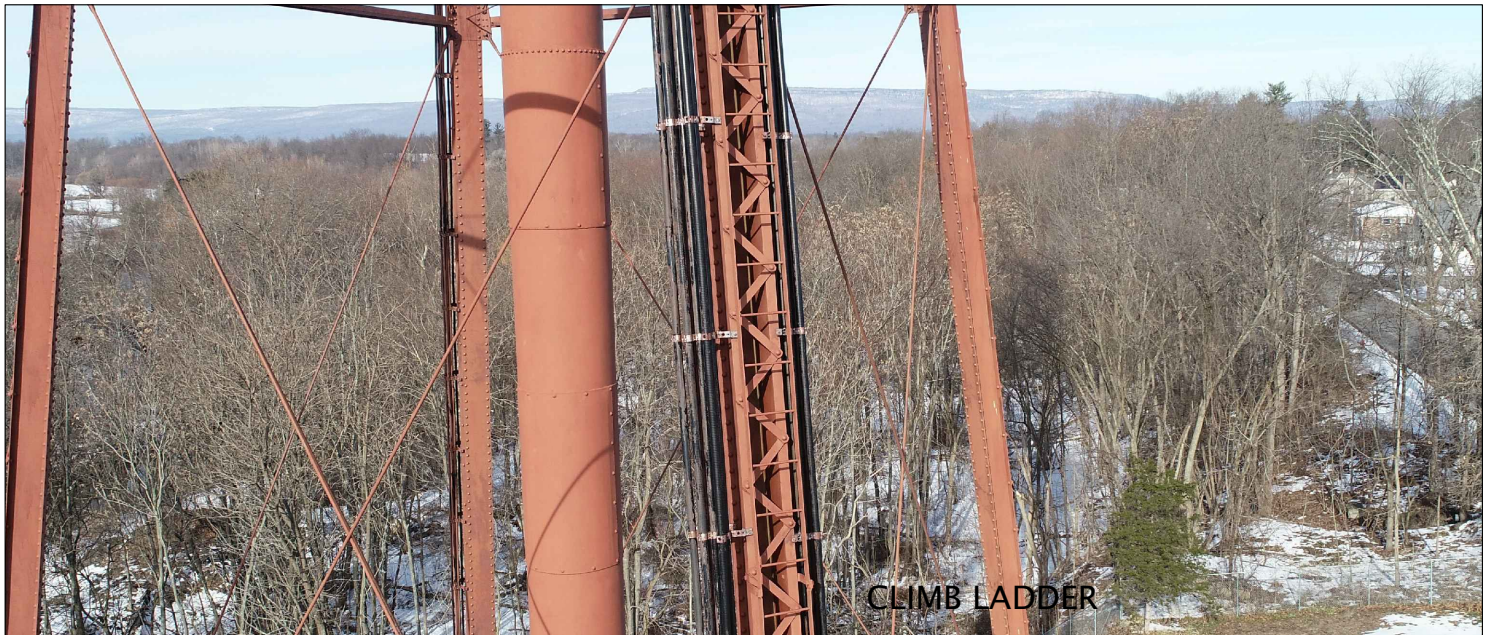
### SAFETY CABLE & LADDER

CLIMB LADDER DOES NOT HAVE A SAFETY CLIMB CABLE.

| Item # | Assessment Item | RATING | 1 | MODERATE | 10 | CRITICAL | Rating | Category | Photo | Comments |
|---|---|---|---|---|---|---|---|---|---|---|
| 5.1 | Components free of physical damage (cracks, wear, corrosion) | | | | | | 10 | | | NO SAFTEY CABLE |

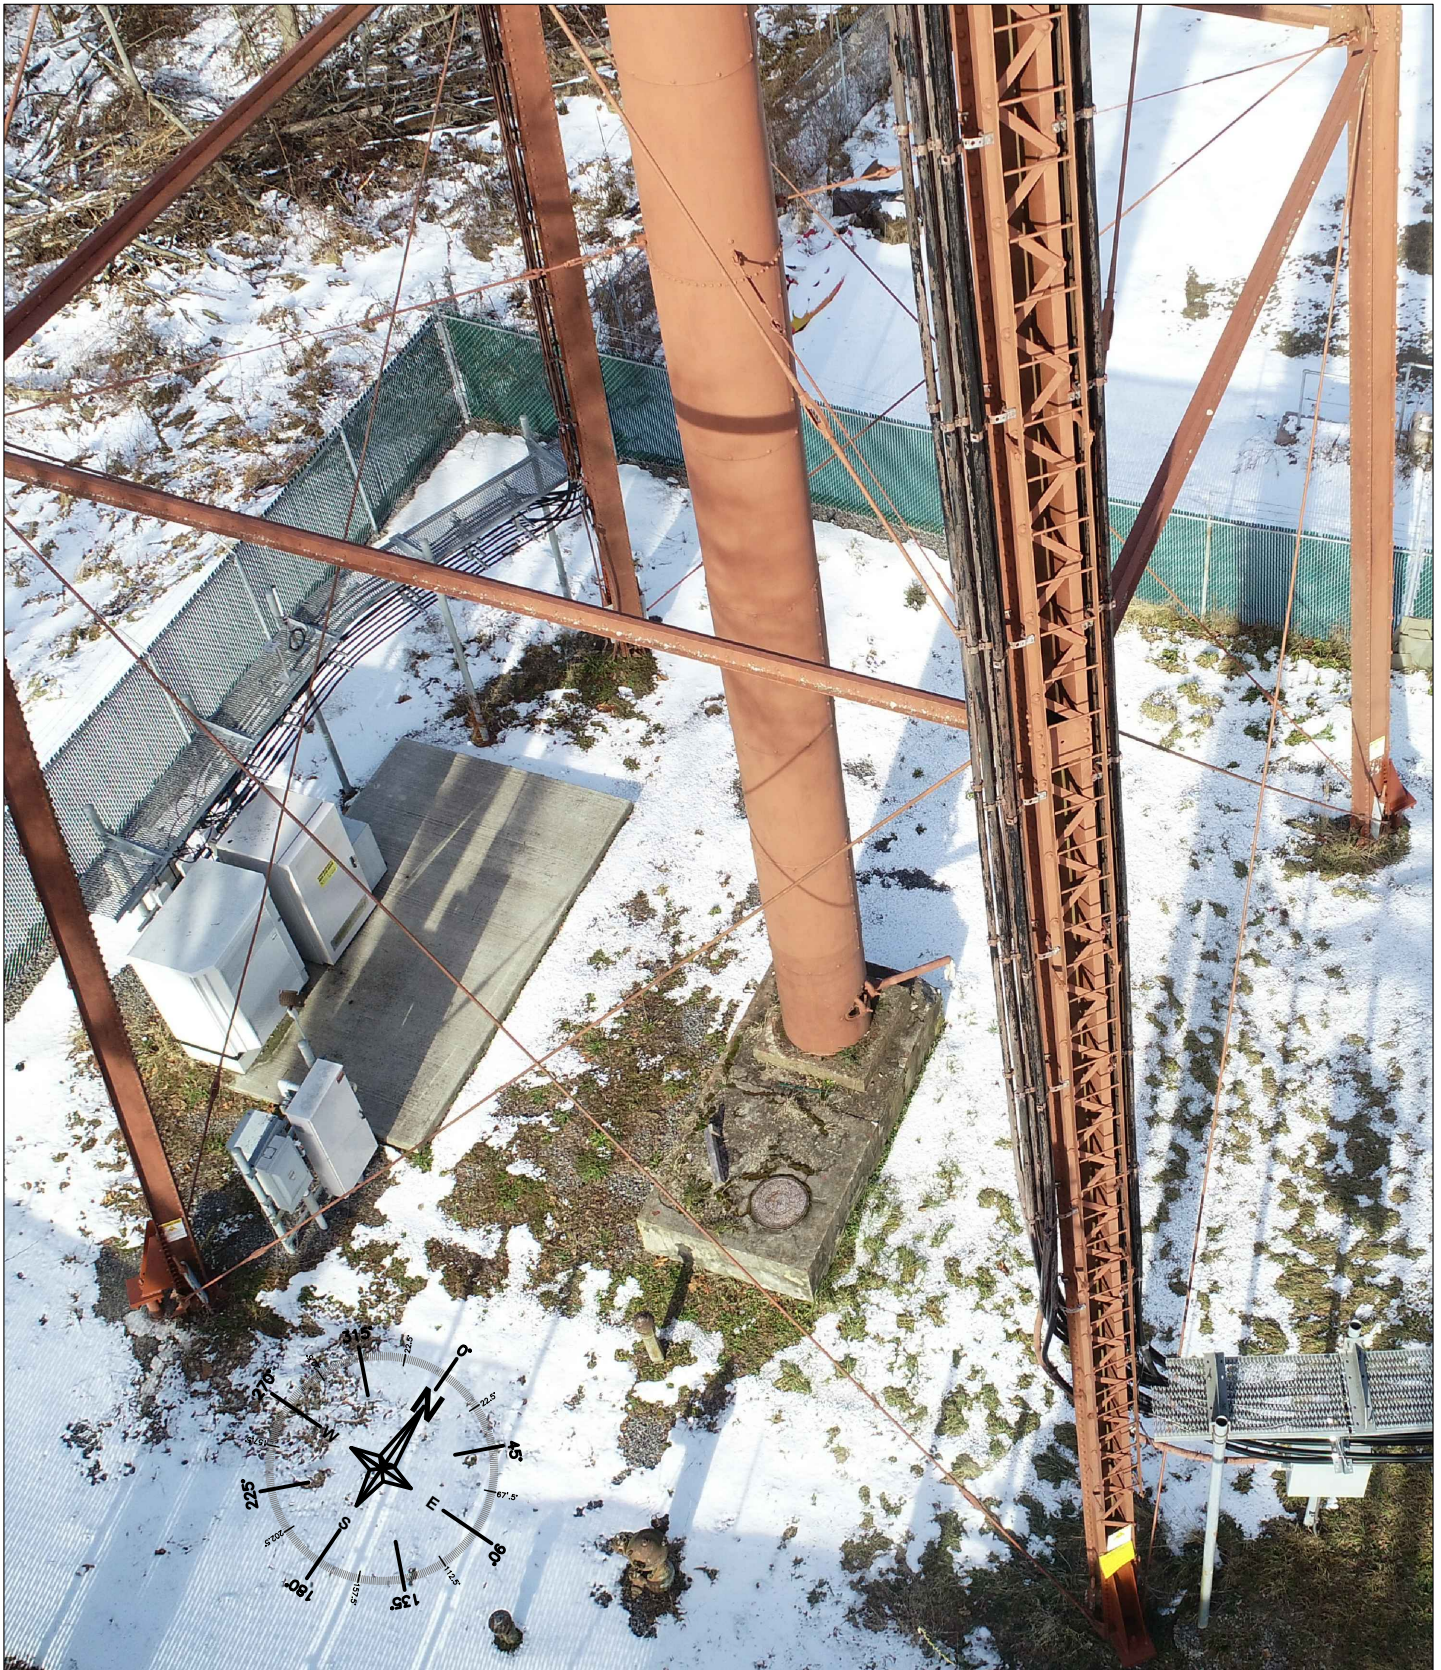
FOUNDATION / SITE

WATER TANK FOUNDATION INSPECTION INDICATED VISIBLE CRACKS AND FAILURES IN NON CRITICAL AREAS OF FOUNDATION.

| Item # | Assessment Item | RATING | 1 | MODERATE | 10 | CRITICAL | Rating | Category | Photo | Comments |
|---|---|---|---|---|---|---|---|---|---|---|
| 3.1 | Concrete and grout (physical condition, cracks, spalling) | | | | | | 4 | | | SCALDING |
