MAINTENANCE AND CONDITION ASSESMENT

SITE ADDRESS:  
CELL SITE ID: 10126045  
FAA SITE NUMBER; NA  
ASSESMENT OF WATER TANK STRUCTURE FOR INFINIGY

ON DECEMBER 12TH 2019 FIREFLY TECHNICAL SERVICES LLC PERFORMED A VISUAL INSPECTION AND MAPPING OF SUBJECT SITE FOR TIA STANDARDS AND GENERAL CONDITIONS ASSESMENT.

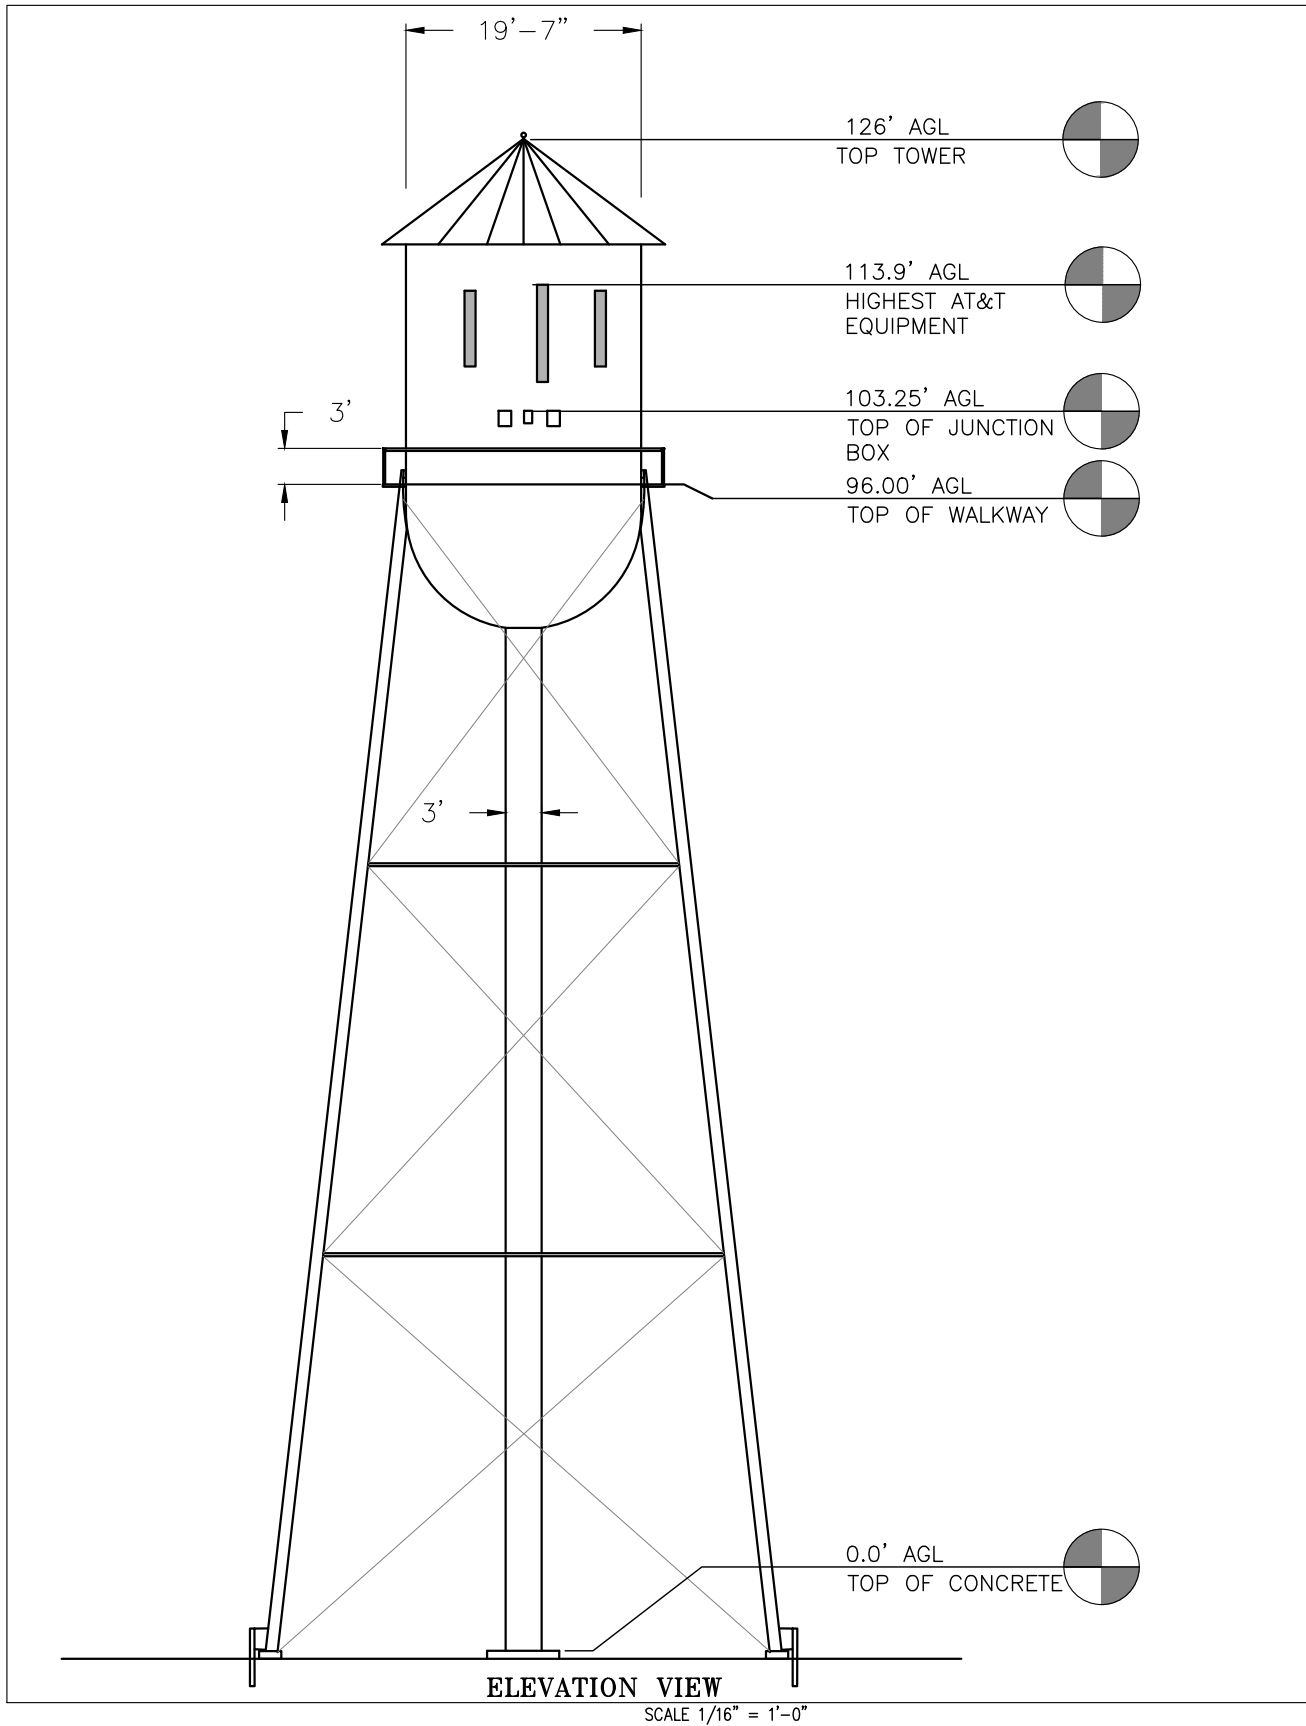
## APPURTENANCE AGL ELEVATION VIEW

LIGHTNING PROTECTION IS NOT THE HIGHEST APPURTENANCE.

CLIMB LADDER DOES NOT HAVE A SAFETY CLIMB CABLE.
